Semi-annual Environmental Monitoring Report

Reporting period: January-June 2023

Batumi Bypass Road Project— Construction of Poti Bridge and Access Roads

Loan No GEO 3520-GEO

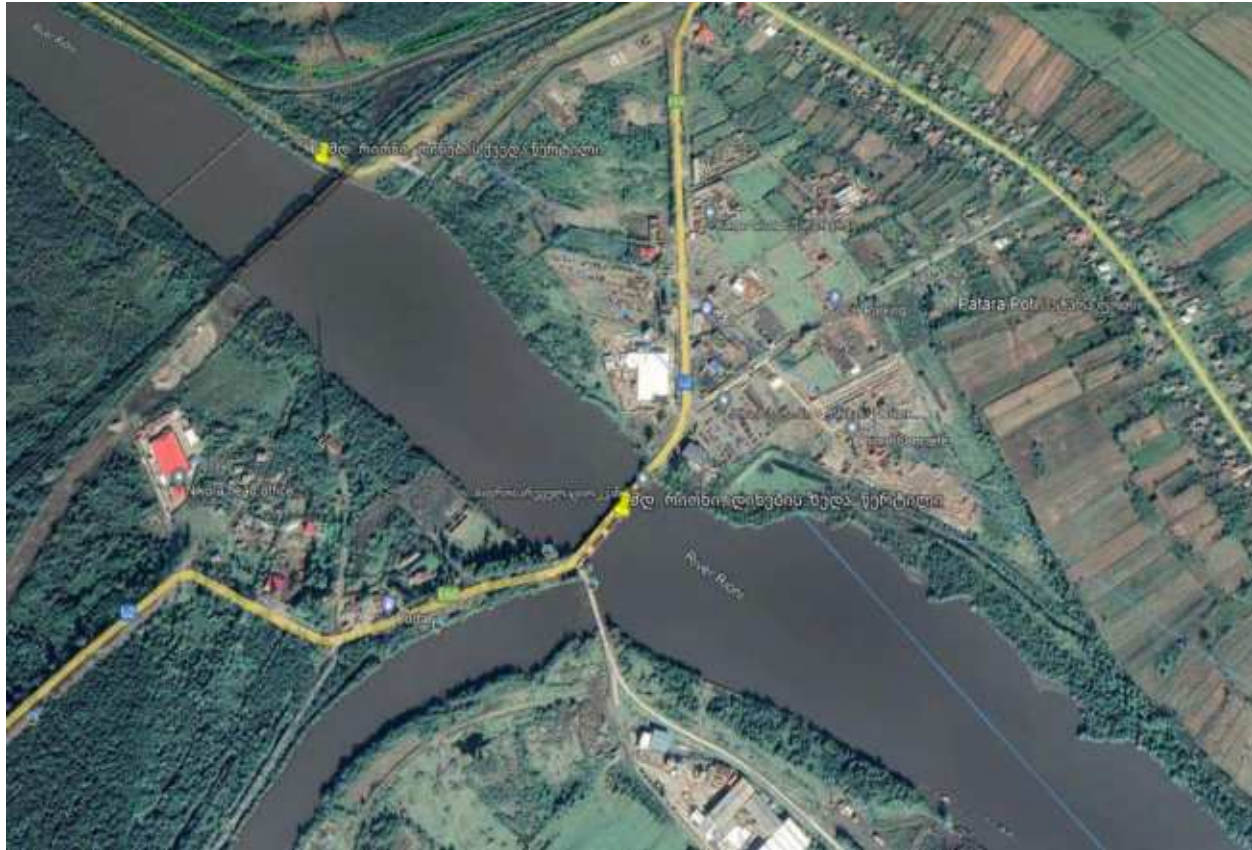
Figure 3. Water Quality Sampling Locations on the Rioni River

Location	Coordinates	
	X	Y
River Rioni downstream	722788	4674713
River Rioni upstream	723505	4674040

37. The results of water quality monitoring for the upstream and downstream sections of the River Rioni are presented in Table 7 and Table 8 respectively. Among the monitored parameters, the levels of ammonia/ammonium ion and chloride ion exceeded the national Maximum Allowable Concentration (MAC) levels during the April monitoring season. There are several possible reasons for these elevated ammonium levels, including the excessive use of fertilizers containing nitrogen in upstream agricultural activities along the river, as well as the decomposition of organic matter such as animal manure and the runoff of human wastewater into the river.

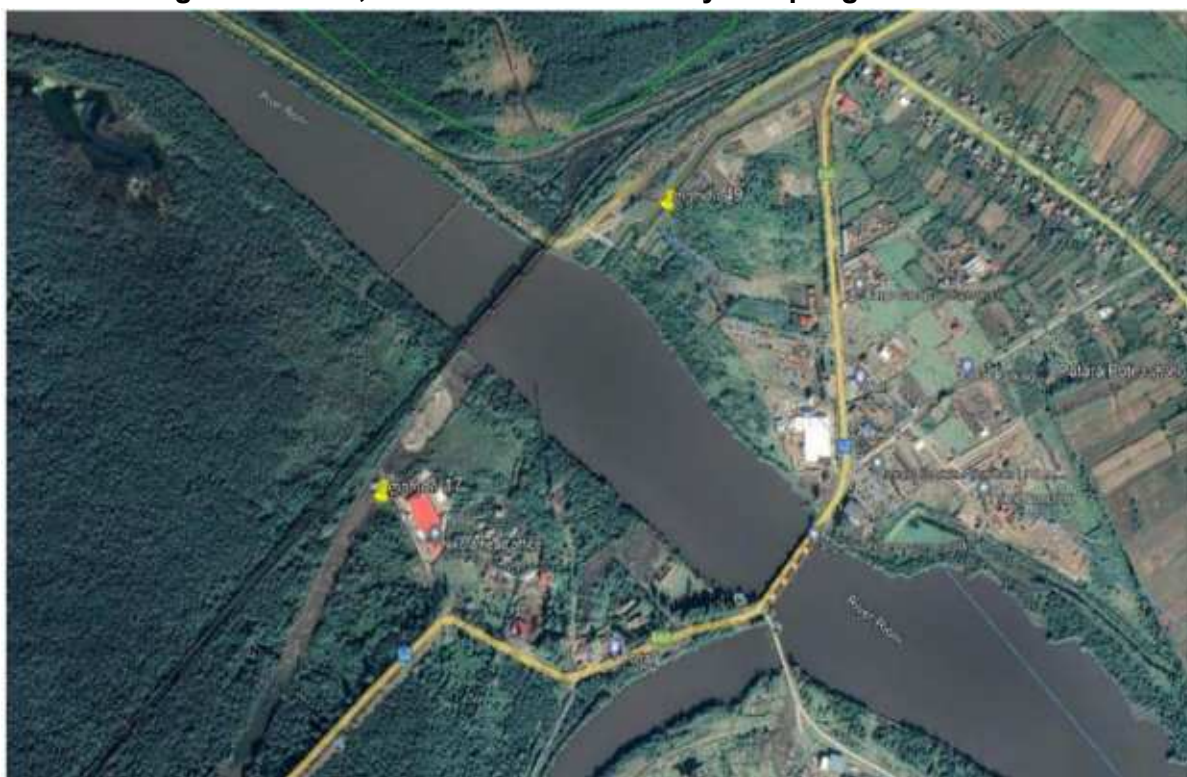
Figure 4. Noise, Vibration and Air Quality Sampling Locations

Location	Coordinates	
	X	Y
Axis 49	723230	4674705
Axis 17	722690	4674127

40. The results of the noise monitoring are presented in Table 10. During the measurement period in May, the noise level exceeded the International Finance Corporation (IFC) standards. However, it is important to consider that, according to the Federal Highway Administration US Department of Transportation's "Noise Measurement Handbook (FHWA-HEP-18-065)", outdoor-indoor noise reduction (OINR) can reduce interior noise levels by up to 25 dB(A) when windows are closed in a building with a masonry structure and single glazed windows. Conversely, with open windows, the reduction is 10 dB(A). The nearest noise-receiving environment for the project is the Nikora Meat Production factory, which is less sensitive than residential areas.

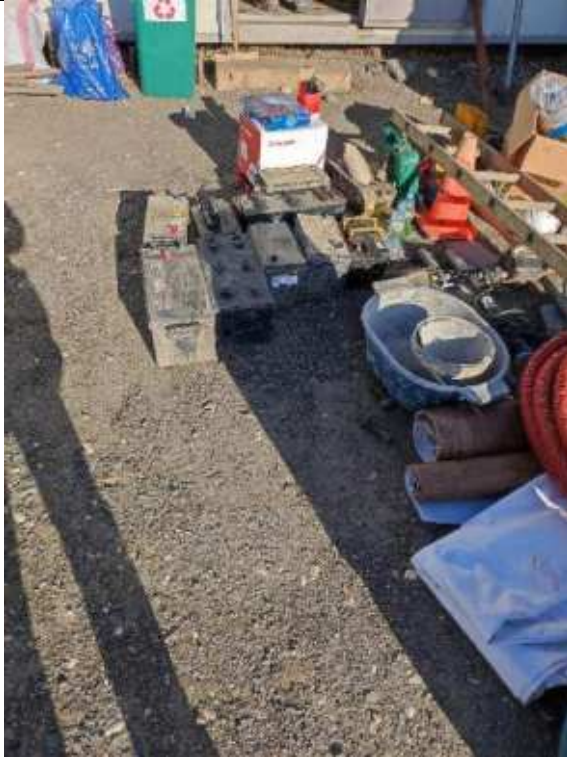
Improperly stored accumulators

- Enhanced handling and storage of hazardous materials: Establishing stricter protocols for the safe handling, storage, and disposal of hazardous materials on site, including proper labeling, appropriate containment measures, and adherence to legal regulations. This ensures the safety of workers and prevents any potential harm to the environment.

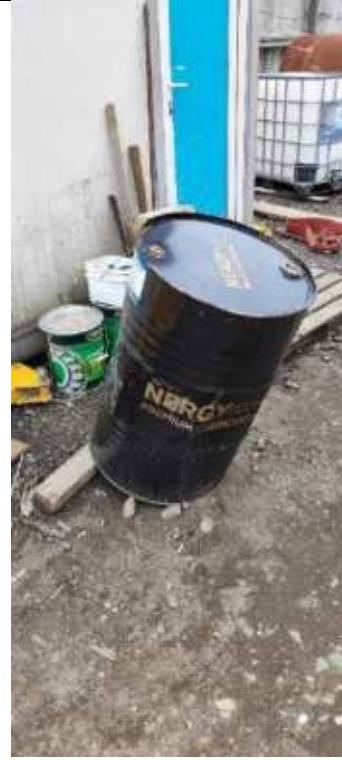
Improperly stored hazardous material containers

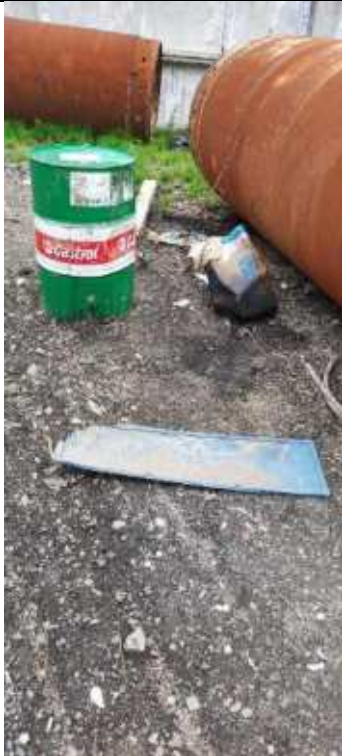
Improperly stored hazardous material containers

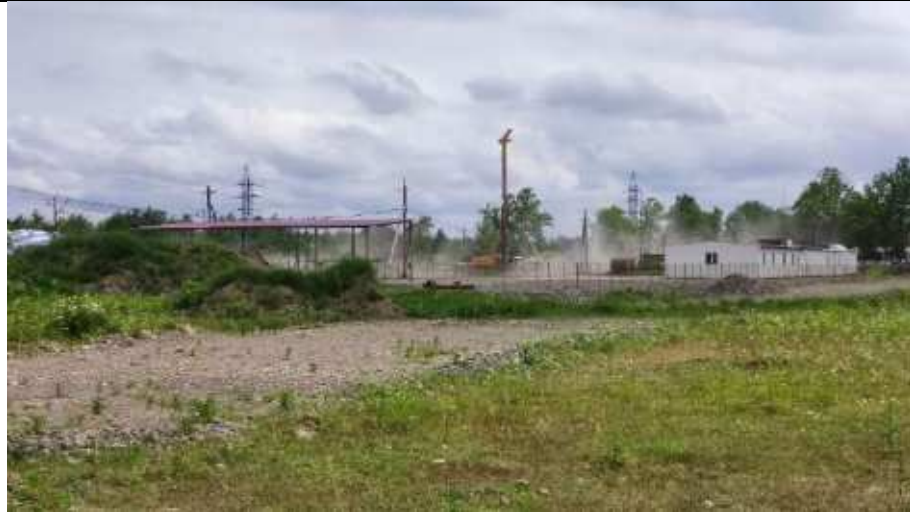
Dust generated during heavy construction machinery movement

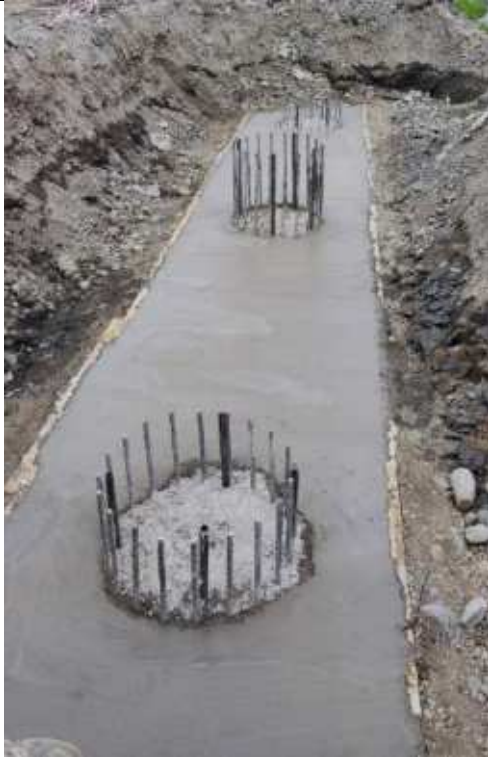
Bridge construction works above the amelioration canal

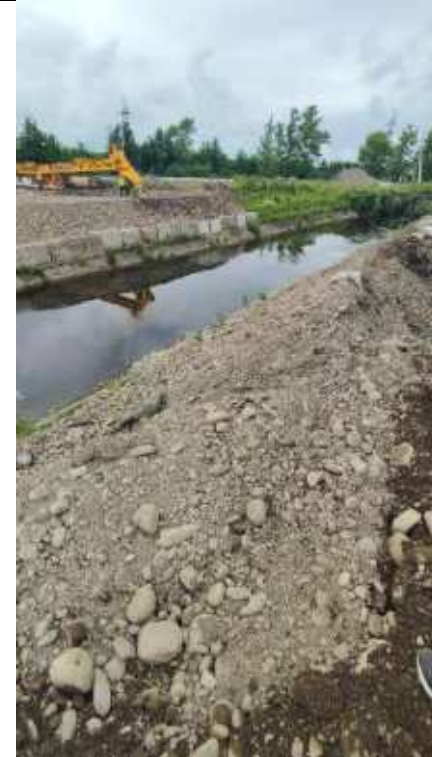
Poor soil embankment management near the amelioration canal

75. Several key areas require improvement in terms of health and safety and environmental practices. These include enhanced topsoil management practices to preserve soil quality and minimize environmental impact through erosion control and proper storage, as well as stricter protocols for the handling and storage of hazardous materials to ensure worker safety and prevent environmental harm. Additionally, implementing more effective dust control measures, strengthening community engagement efforts, expanding waste reduction initiatives, prioritizing safety measures during excavation works, and improving traffic safety measures are crucial areas for improvement. These actions will enhance overall safety, minimize environmental impact, and promote the well-being of workers and the community.

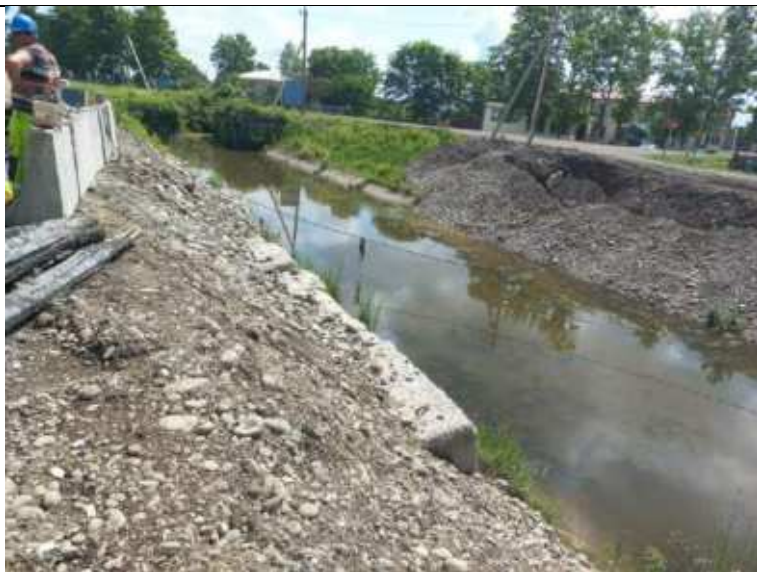
Poor soil embankment management near the amelioration canal

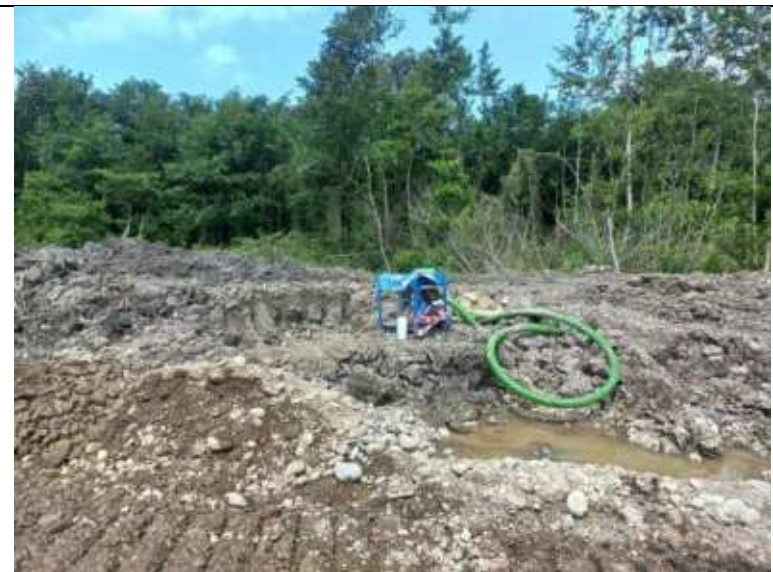
Water pumping from the small ponds in the eastern part of the project

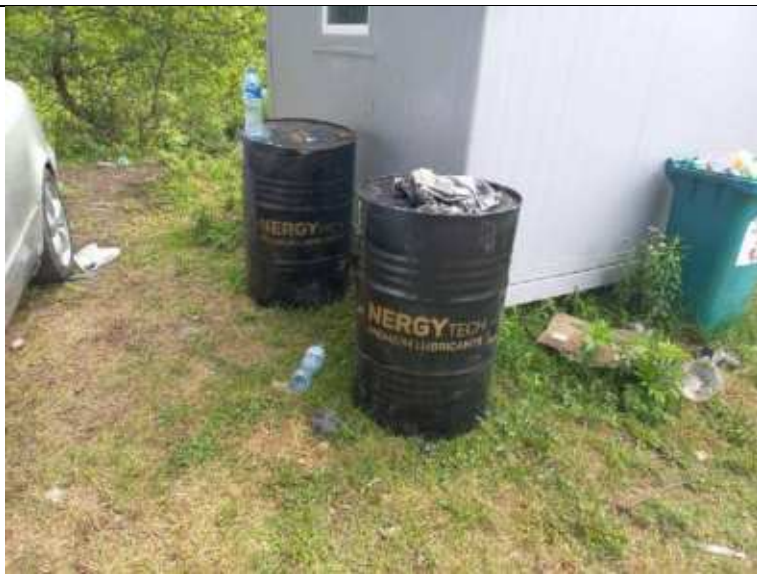
Improperly stored hazardous material containers

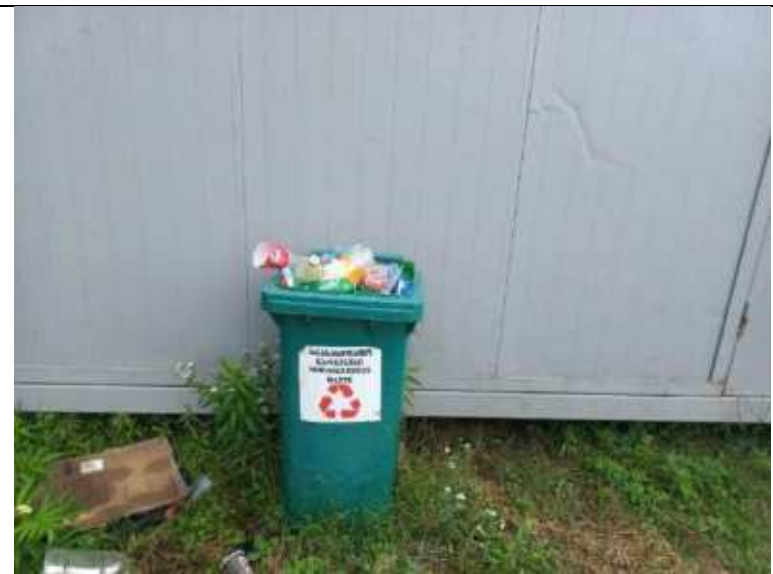
Full waste bin

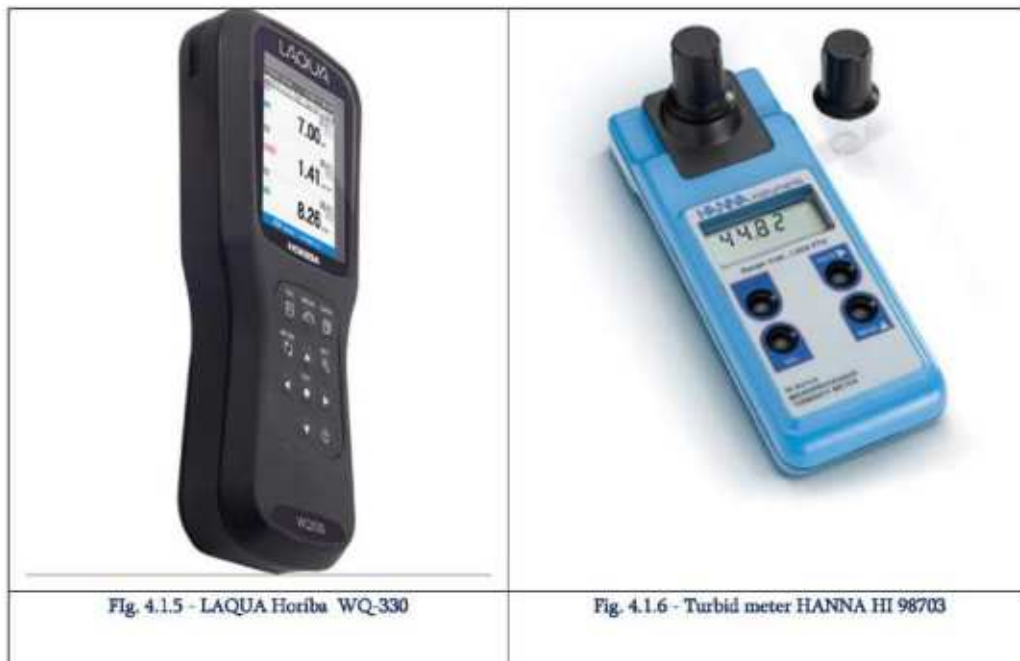
<p>Fig. 4.1.1 - Gasella Mikro Dust Pro 712</p>	<p>Fig. 4.1.2 - AR63B Vibration Meter</p>

<p>Fig. 4.1.3 - Mini Sound Level Meter N05CC</p>	<p>Fig. 4.1.4 - Multiparameter Water Quality Meter</p>

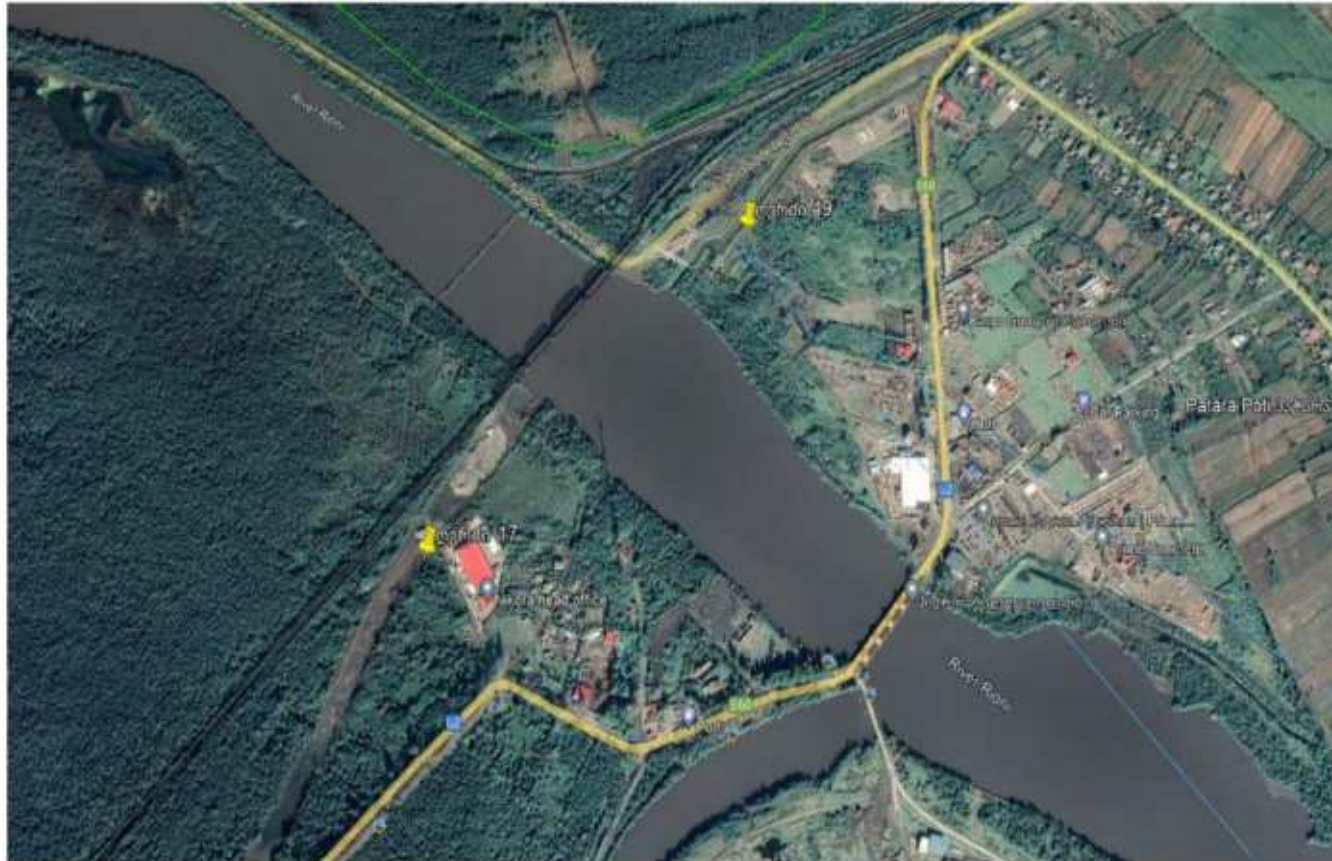
Fig. 4.1.7 - Location of monitoring points for noise, vibration, dust and other pollutants in ambient air

GPS coordinates of monitoring points for noise, vibration, dust and other pollutants in ambient air are given in table 4.1.1. while, the coordinates of water sampling points from Rioni River are given in Table 4.1.2. In addition, monitoring points are marked on maps 4.1.7 and 4.1.8.

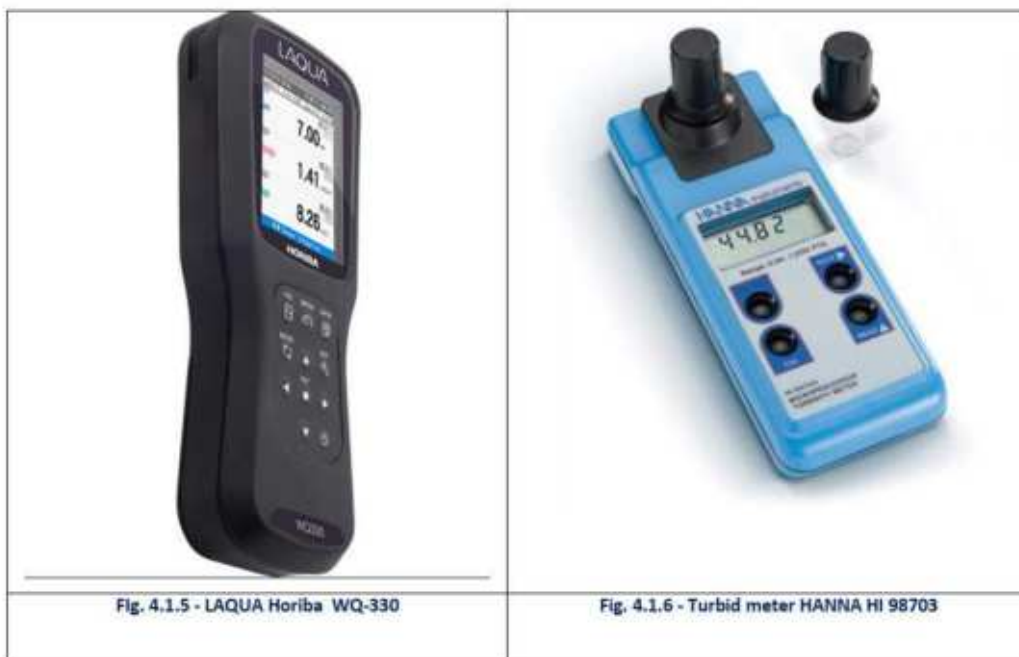
<p>Fig. 4.1.1 - Gasella Mikro Dust Pro 712</p>	<p>Fig. 4.1.2 - AR63B Vibration Meter</p>

<p>Fig. 4.1.3 - Mini Sound Level Meter N05CC</p>	<p>Fig. 4.1.4 - Multiparameter Water Quality Meter</p>

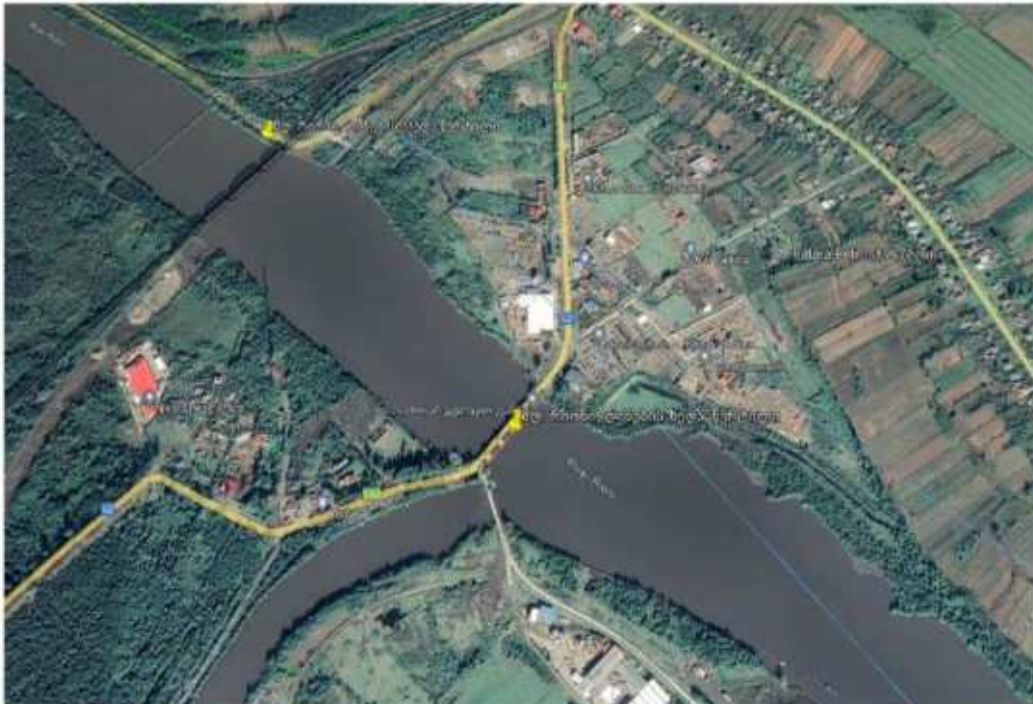
Fig. 4.1.8 - Location of monitoring points of water taken from Rion River

Monitoring point		
#	Location	GPS coordinate
1	Riv. Rioni downstream point	X - 722788 Y - 4674713
2	Riv. Rioni upstream point	X - 723505 Y - 4674040
